***Property Inspection Report for:  
Mr. & Mrs. Buyer***

***2000 Anystreet  
Anytown, USA 51111***

# Building Inspection Report

**Report Number:**  
2-2622

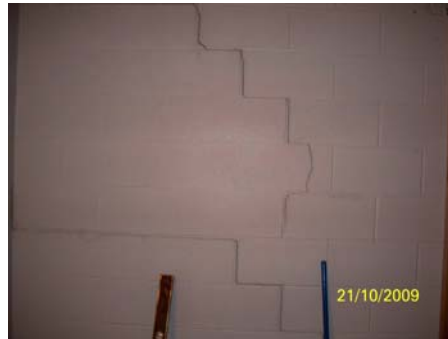
1.) Settlement crack on west wall.

- **Monitor:** Larger than typical foundation settlement cracking was observed on the west wall of the furnace room. The amount of movement which has occurred is not likely to have caused other damage to the structure but this area should be monitored. If additional movement occurs, more costly repairs might be necessary. The rate of movement cannot be predicted during a one-time inspection. (See photo's #1 and 2)
- **Monitor:** Common minor settlement cracks were observed in the foundation walls on the east wall of the furnace room. This implies that some structural movement of the building has occurred. Cracks of this type should be watched for any sign of additional movement. In the absence of any sign of ongoing movement, repair should not be necessary.

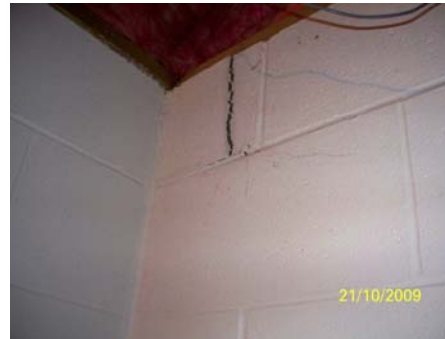
2.) Displacement of block on west wall.

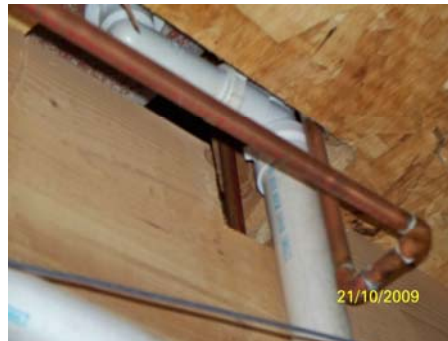
- **Monitor:** Minor unevenness was observed in the floor structure in the master bathroom. This condition is common. It may be the result of the materials, framing design, installation methods and aging of the building. There was not evidence of need for immediate, costly repair.
- **Repair:** Floor joists are notched and or cut under the bathrooms. This weakens the joist and risks structural damage; repairs or additional support are needed. (See photo #3)

3.) Notched floor joist.

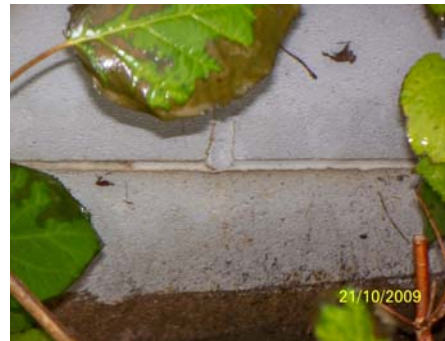
- **Monitor:** Common minor shear cracks were observed on the west exterior walls of the garage. This implies that structural movement has occurred. The location, size, shape of these cracks is common. The inspection did not find evidence of significant movement requiring immediate major repairs. (See photo #4)

4.) Sheer crack on west exterior wall of garage.

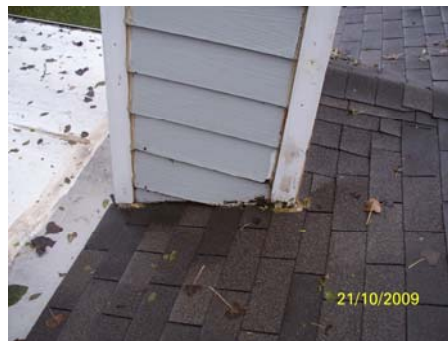
- **Repair:** The clearance of the siding at the flashing at the chimney is insufficient. This condition leaves the siding vulnerable to rot. This detail is usually repaired when siding needs repair or replacement or when re-roofing work is performed. (See photo #5)

5.) Insufficient clearance siding/roof.

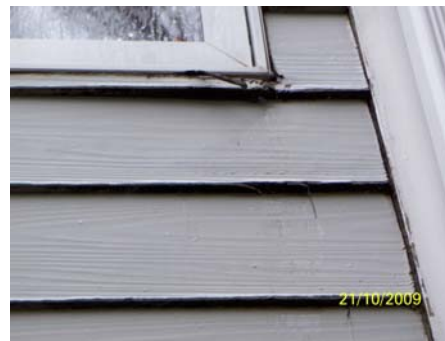
6.) Deteriorated siding.

- **Repair:** All exterior wall penetrations for the utility lines should be well sealed to prevent moisture penetration behind the siding material.
- **Repair:** Localized rot was observed in the siding under the north bow window in the living room and at the chimney chase. Following repair of the damaged areas (which should be combined with exterior painting/maintenance) proper maintenance of the siding and control of water from roof or surface runoff can avoid further damage. (See photo #5, 6 . 7 and 8)

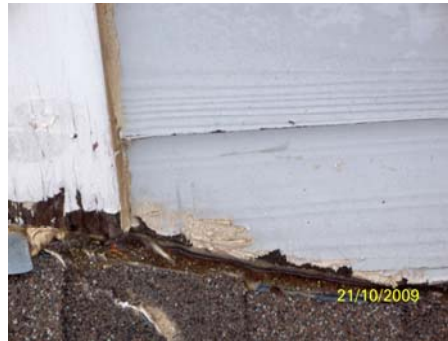
7.) Deteriorated siding at chimney.

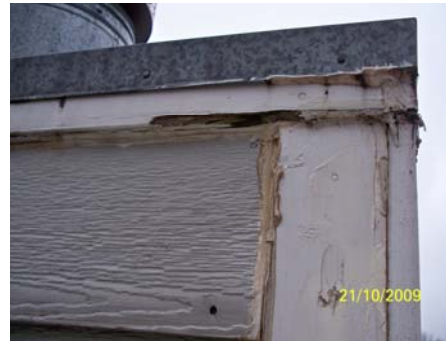
8.) Deteriorated siding trim at chimney.

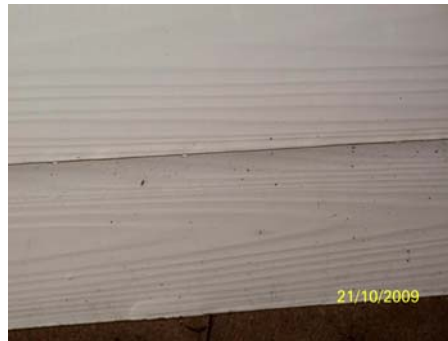
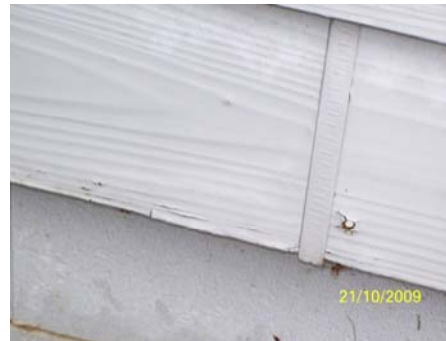
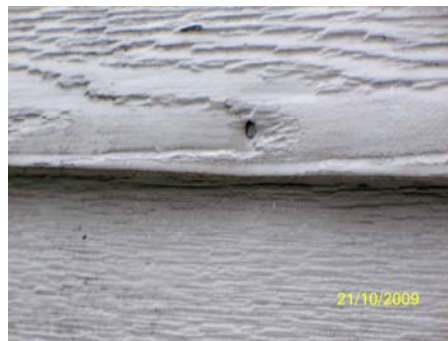
- **Repair:** The siding material is delaminating (coming apart) in various locations. Localized repairs, replacement and/or painting may extend the life of the siding. Wholesale replacement may eventually be necessary – a significant expense which can be deferred when only limited areas of damage are found.(See photo's #9, 10 and 11)

9.) Siding delamination.

10.) Siding delamination.

11.) Siding delamination.

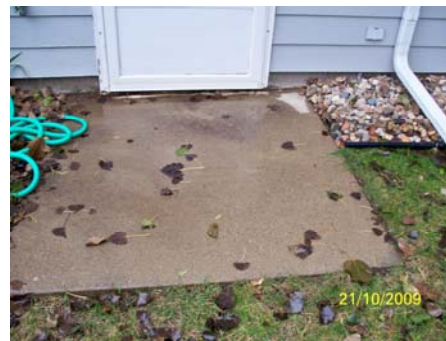
- **Repair:** The grading at the west side of the home should be improved to promote the flow of storm water away from the house. This can often be accomplished by the addition of top soil. The ground should slope away from the house at a rate of one inch per foot for at least the first ten feet. At least eight (8) inches of clearance should be maintained between soil level and the bottom of exterior wall siding.
- **Repair:** The concrete slab at the basement doorway is sloped towards the house and water was pooling at the foundation. This should be repaired to avoid water penetration to the interior of the basement. (See photo #12)

12.) Slab sloped towards home.

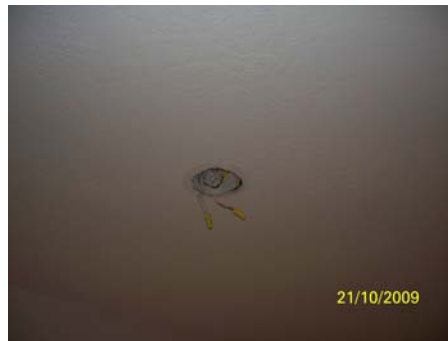
- **Repair:** The light fixture in the living room has been removed and there are exposed wires. This light should be replaced or the wires properly terminated. (See photo #13)

13.) Missing light fixture.

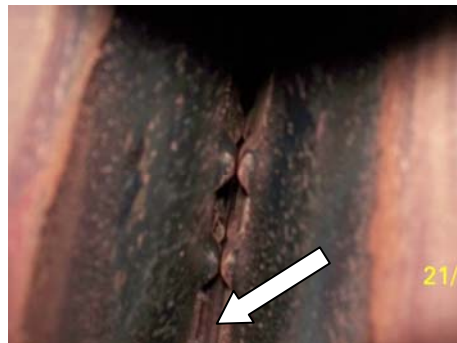
- **Possible Major Concern, Repair, Safety Issue:** The furnace heat exchanger appears to be cracked in two locations. *This condition is a carbon monoxide safety risk.* A qualified service technician or utility company representative should be engaged to thoroughly examine the exchanger and make repairs as recommended. (See photo #14 and 15)

14.) Possible crack in exchanger.

15.) Possible crack in exchanger.

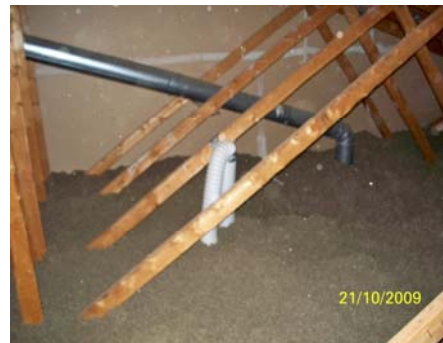
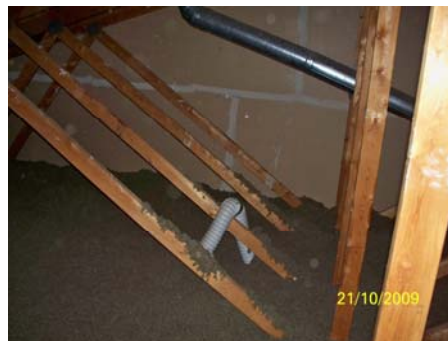
- **Improve:** The attic access hatch should be better insulated.
- **Repair:** Bathroom exhaust vent pipes should be insulated and vented to the building exterior. The main floor are bath vents are currently vented to the attic space. (See photo's #16 and 17)

16.) Bath exhaust vented to the attic.

17.) Bath exhaust vented to the attic.

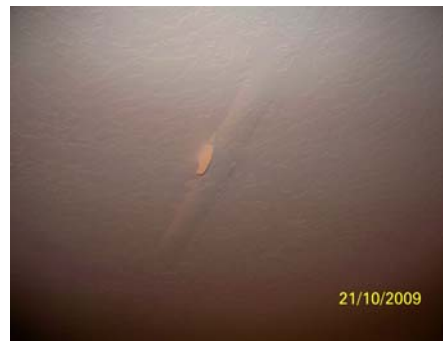
18.) Drywall flaw in ceiling of north bedroom.

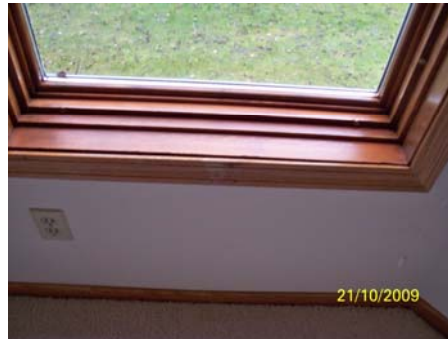
19.) Water stain on sill.

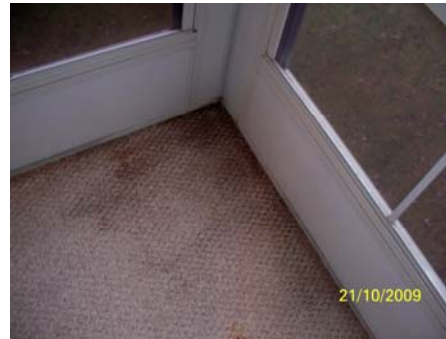
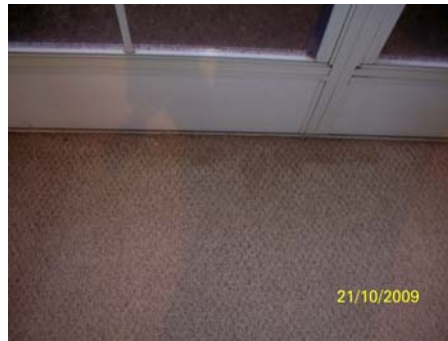
20.) Past water penetration at three season porch.

21.) Past water penetration at three season porch.

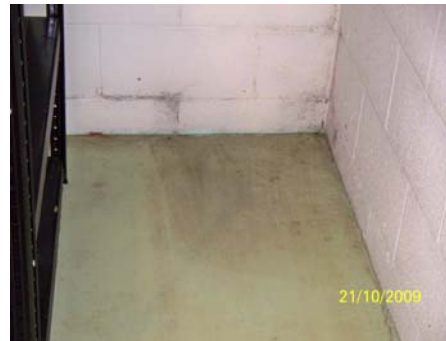
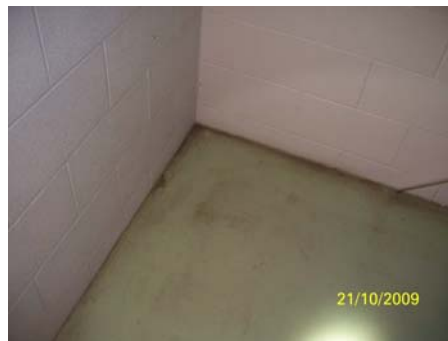
22.) Evidence of past moisture in basement.

23.) Evidence of past moisture in basement.

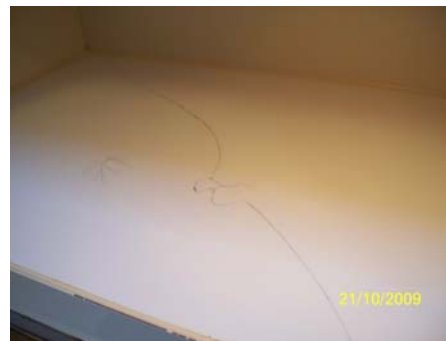
24.) Crack shelf in microwave.
